CONDITION REPORT

# The Old Creamery Works, Ashwell.

Eight faults across seven areas.

The Old Creamery Works, Barton Lane,  
Ashwell Moor, Somerset, TA20 9GZ

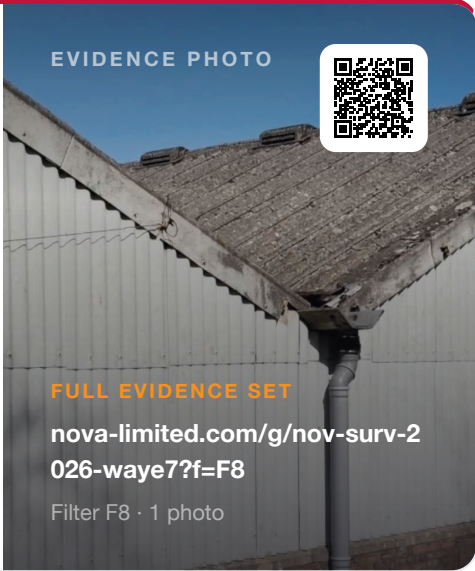
# F8 Failed flashing

Flashings at each elevation have been found to be lifted, cracked, detached or absent. Deterioration or absence of the flashing detail at roof-to-wall, roof-to-roof and eaves junctions allows water penetration at these vulnerable interfaces, with risk of progressive damage to the building fabric, insulation and internal finishes.

Remove and dispose of all failed flashing sections. Supply and fix new colour-matched flashings formed from minimum 0.7mm polyester powder coated steel to all affected junctions, lapped a minimum of 150mm at joints and fixed at 450mm centres with colour-matched self-drilling screws and EPDM-backed washers. Profile foam fillers to be supplied and fixed at all sheet-to-flashing junctions prior to flashing installation to close the profile void and prevent wind uplift.
